Pentium® Pro Processor Specification Update

Release Date: February 1998

Order Number: 242689-025

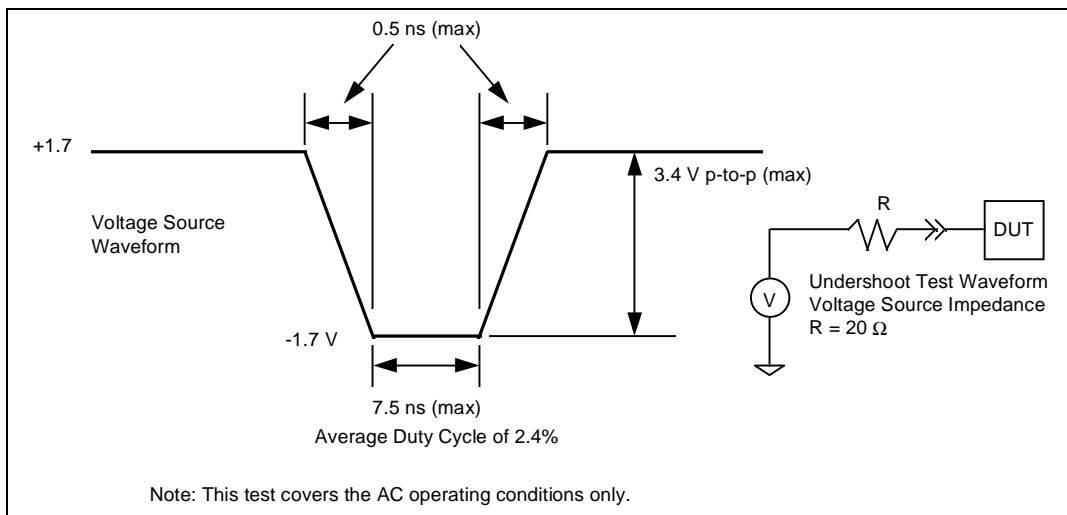
The *Pentium® Pro Family Developer's Manual, Volume 1: Specifications*, Section 11.15., will include the following undershoot specification, to simplify signal integrity issues on signals that can be driven by more than one device simultaneously:

The Pentium Pro processor bus signals AERR#, BERR#, BINIT#, BNR#, HIT#, and HITM# (only) are capable of sinking an 85 mA current pulse at 2.4% average time duty cycle. This is equivalent to -1.7V applied to a 20Ω source in series with the device pin for 8 ns at 66 MHz with a utilization of 5%.

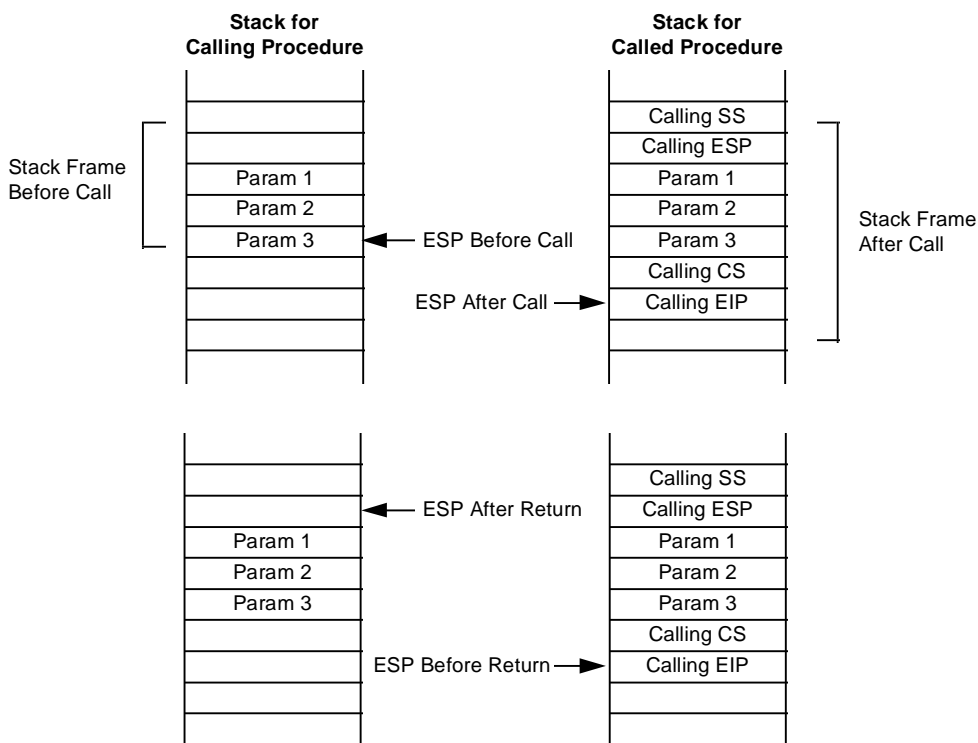
Figure 4-3. Stack Switch on a Call to a Different Privilege Level

Note: On a return, parameters are released on both stacks if the correct value is given for the *n* operand in the RET *n* instruction.

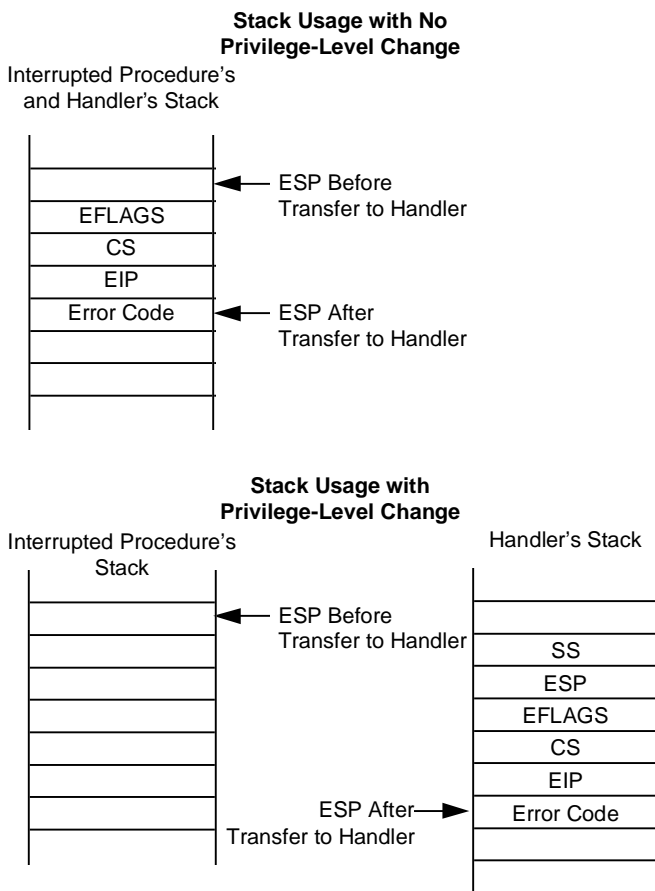
Figure 4-4. Stack Usage on Transfers to Interrupt and Exception Handling Routines

When executing a return from an interrupt or exception handler from a different privilege level than the interrupted procedure, the processor performs these actions:

1. Performs a privilege check.
2. Restores the CS and EIP registers to their values prior to the interrupt or exception.
3. Restores the EFLAGS register.
4. Restores the SS and ESP registers to their values prior to the interrupt or exception, resulting in a stack switch back to the stack of the interrupted procedure.
5. Resumes execution of the interrupted procedure.
